Investigation of Fire Impact on Structural Steel through Case Studies

A Thesis Report

WORCESTER POLYTECHNIC INSTITUTE

Date: May 4, 2006

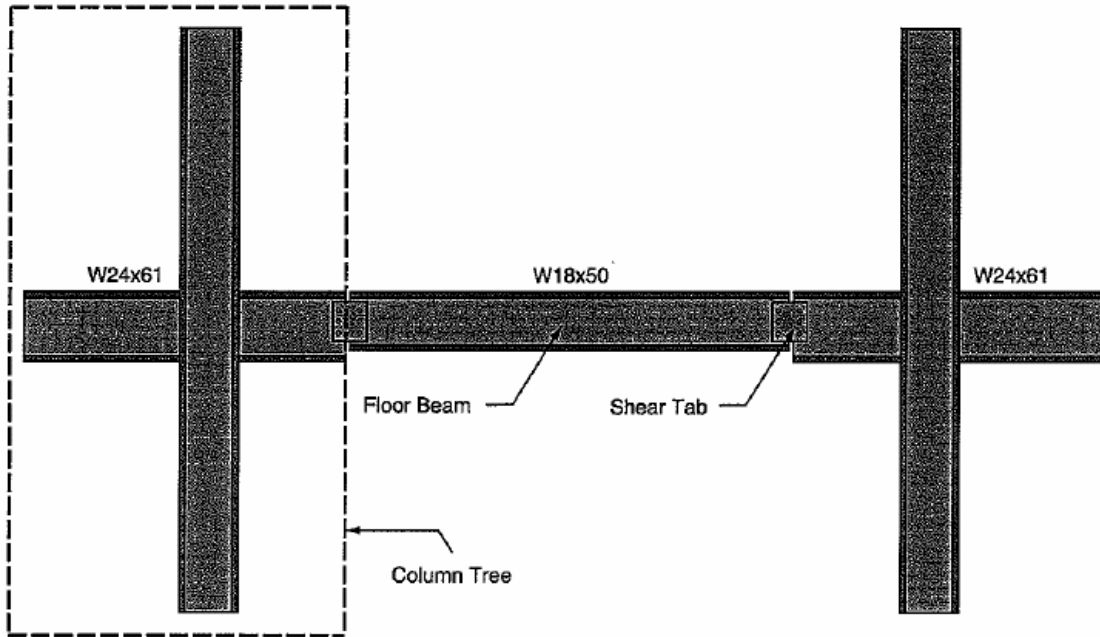
World Trade Center 5 was a nine-story office building that was completed around 1970. Fire in this building broke out due to debris that impacted the building from the collapse of the World Trade Center towers on September 11, 2001. The subsequent fires caused shear connectors of the column tree assemblies to fail initiating collapse from the eighth floor through the fifth floor. The roof and ninth floor (which contained no column trees) as well as the fourth floor and floors below experienced no collapse. The column tree assemblies and conventional framing systems can be seen in Figures 7 and 8 below.

Figure 7 - Typical Column Tree System (Barnett, 2002)
