**Structural and Nonstructural Building System Performance During
Earthquake and Post-Earthquake Fire**

Fire Test Program – Executive Summary

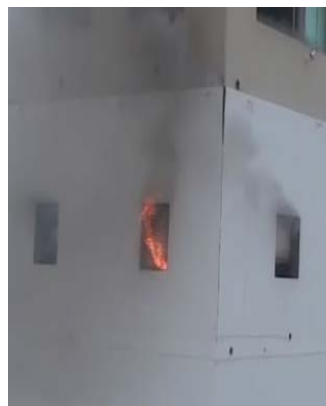
Flame Out Window

Although it was not possible to test actual windows during these tests, window openings were provided and tested in various conditions, including completely closed, partially closed and fully open. In tests where the windows were fully opened, flame extension was observed, smoke venting was observed, and the test fires were exposed to wind-driven conditions, which affected the combustion rate, smoke spread and flame angle direction during the fire tests.

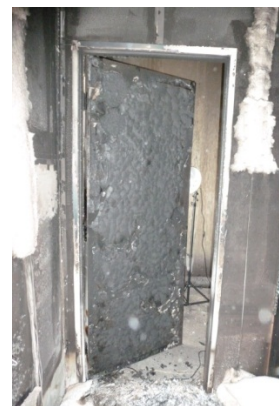
Door After Test

Some of the doors installed on Floor 3 were not functioning properly after the motion tests. In some cases doors were not able to close completely because door frames were distorted and locks were damaged. The potential fire performance concern here is that smoke and fire could spread through a door, which was designed to be closed during fire, hindering occupant egress and safety. In another instance, a door on Floor 3 was jammed closed during a ground motion test, requiring tools to be used to pry the door open. The potential fire performance concerns here are that occupants can be hindered when trying to escape, placing them at risk, and the fire service can be hindered when undertaking rescue and firefighting operations.

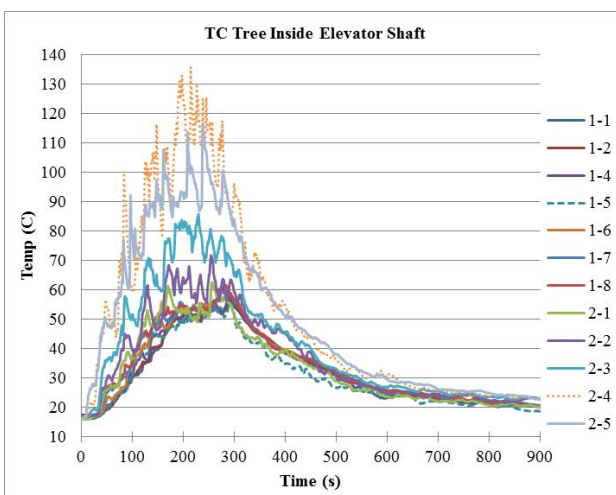
As noted above, the elevator was non-operable following the largest ground motion because the elevator doors and frames became distorted on several floors, with openings as large as 24 cm (9.4 inches) on the third floor. One potential fire performance concern is loss of compartment integrity and spread of fire and smoke, in this case allowing for vertical smoke (and fire) spread. The elevator shaft interior temperatures were greatly increased as smoke and hot gases from the elevator lobby fires were entrained into the shaft through the opening on Floor 3. An additional potential fire performance concern is the loss of elevators for occupant egress and for fire department rescue and suppression support operations.
