Preservation and Restoration of Venetian Public Art

From the Completion of the Public Art Catalog to the Active Restoration Process

An Interdisciplinary Qualifying Project
Submitted to the faculty of
Worcester Polytechnic Institute
in partial fulfillment of the requirements for the
Degree of Bachelor of Science

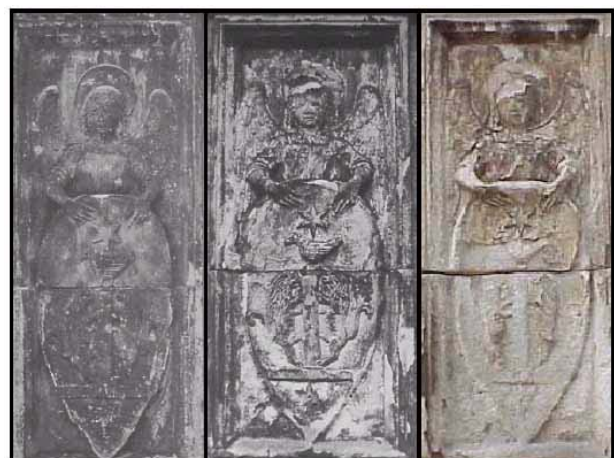
Figure 10: Public art deterioration

students from the VPC, this is approximately one percent of the entire collection⁶. Through comparisons with this catalog, we also can see how quickly the artwork is deteriorating. **Figure 10** shows the effect of time on the angel relief, constructed in Cannaregio in 1485. The pictures were taken over the span of 70 years, from the first in 1930, to Rizzi's in 1979, to the recent VPC catalog in 2000.

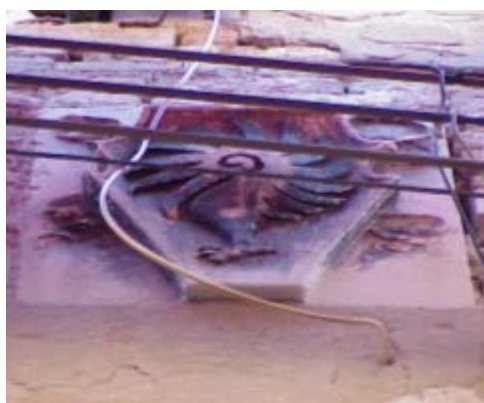
Figure 12: Wires on and around public art

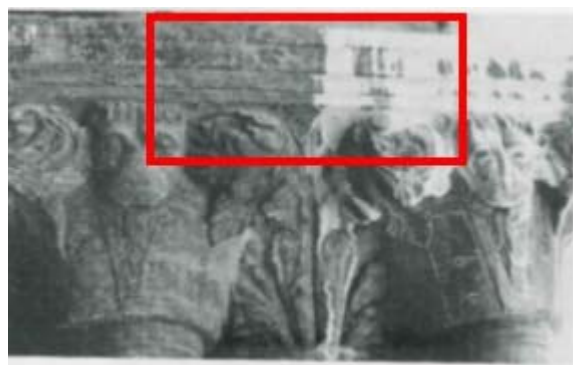
Figure 11: Blackening caused by atmospheric pollution, and whitening produced by trails of rainwater⁷.

Some of the decline in the quality of the art is a result of man-made pollutants which advance the deterioration of stone. Sulfuric acids are released into the air from industrial zones; when they are combined with moisture from humidity they convert

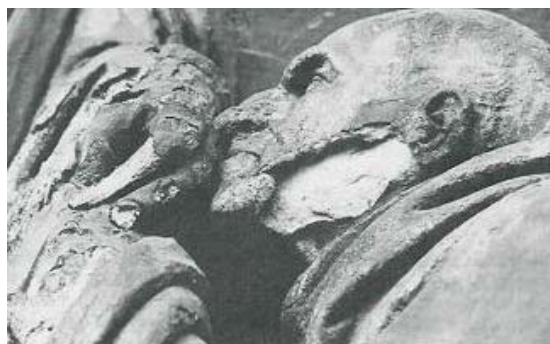
Figure 21: Relief with partially missing or endangered facial features²¹

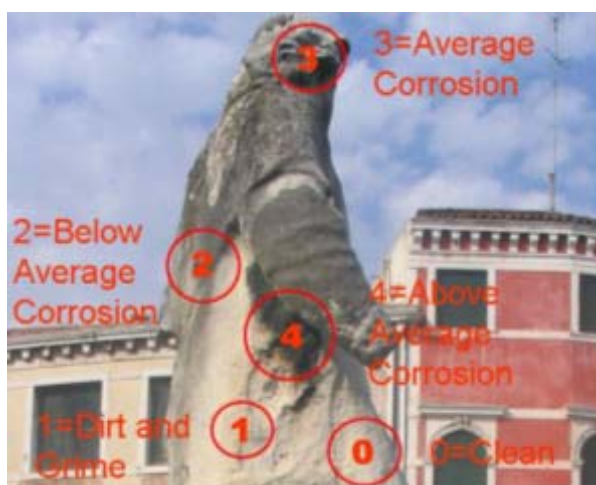
Figure 22: Severity Condition Assessment

When ranking the condition of each monument we first ranked the part of the statue that was in the worst condition. Based on the conditions set forth in the *portali* section 3.3.3, we have conducted condition assessments of each statue and each base level of the monument. Through counting the number of cracks in each severity level we have made special note of the most severe parts of each portion of the monument.

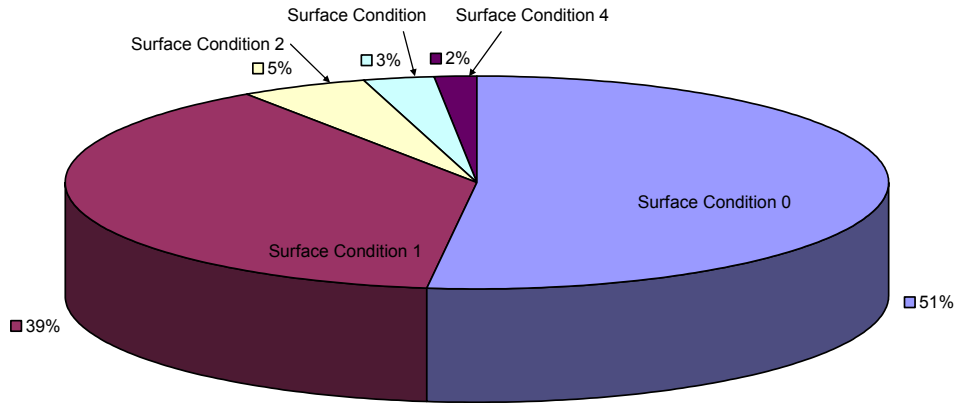
Figure 30: Surface Condition Distribution

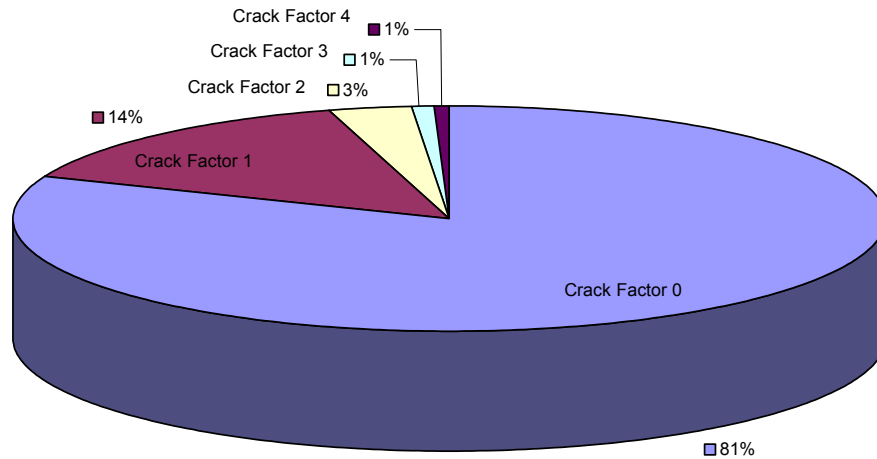
Figure 31: Cracks distribution

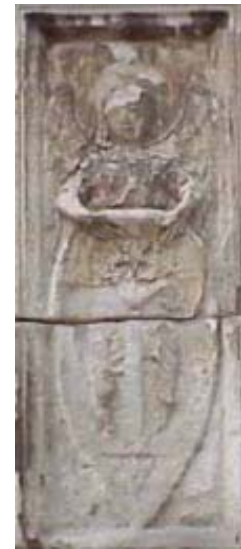
Figure 35: Relief of the angel

A relief of an angel (catalog number CN300) located in the *sestiere* of Cannaregio was the first restoration process we began. The process serves as a model for the Association for the Preservation of Venetian Public Art. The angel is located on the building adjacent to the *Settemari* rowing club of which Professor Fabio Carrera is a member. The rowing club provided the funds for the restoration, and one of the members is inline to perform the restoration. Some preparations had been started before the beginning of our project process. Work within the rowing club and the VPC lead to a draft of a letter to the *soprintendenza* asking for the proper permits, a letter to the Venice police asking for permission for overnight scaffolding for the restoration work on the angel, and a letter to the owner of the building asking him for permission for all the work that needs to be done. Upon our arrival in Venice, the angel had been covered with a temporary protective covering to prevent further destruction.

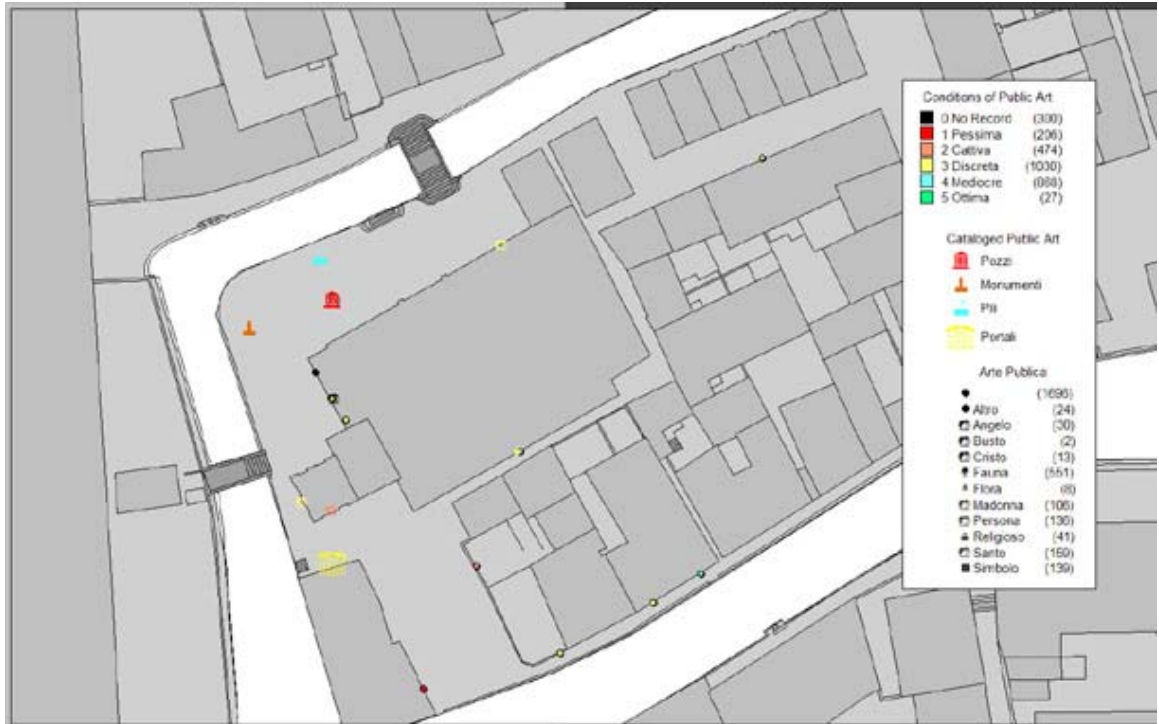
Figure 37: Uniqueness and condition of public art on San Nicolò dei Mendicoli

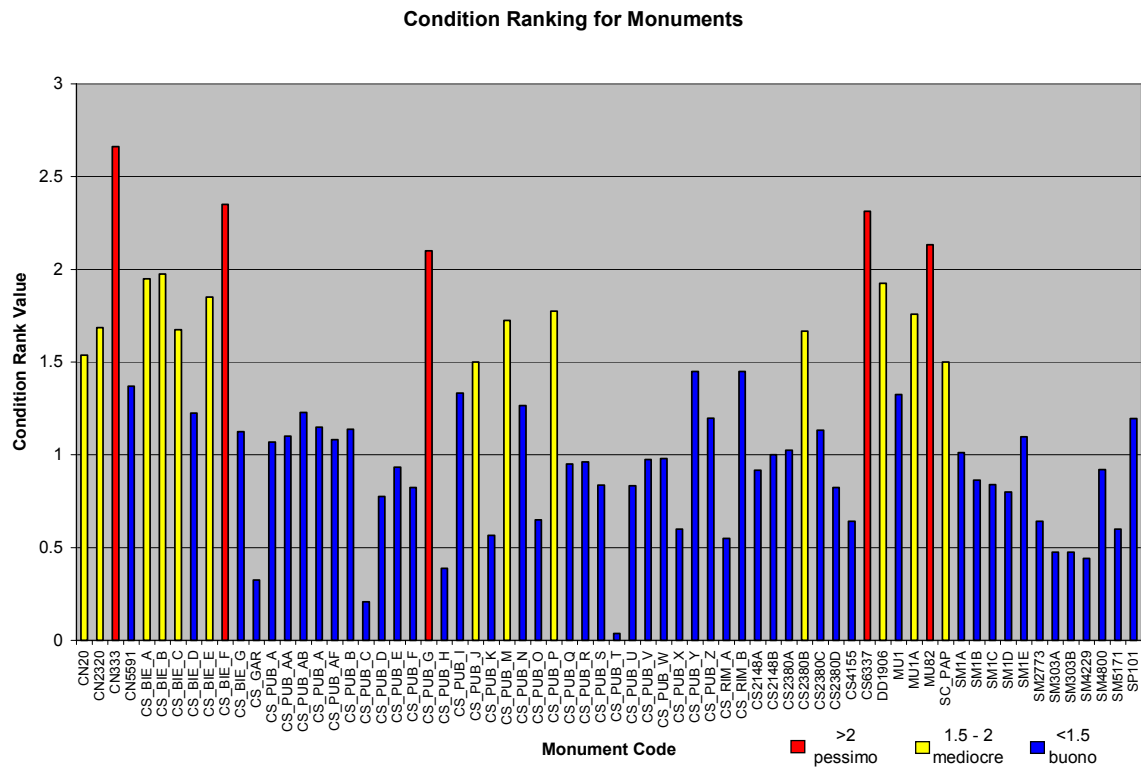
Figure 40: Monument condition rankings

40 below, the conditions are indicated in red, yellow, and blue, respectively. The map, illustrated in **Figure 41**, shows the distribution of the conditions of the monuments in the historical center of Venice.

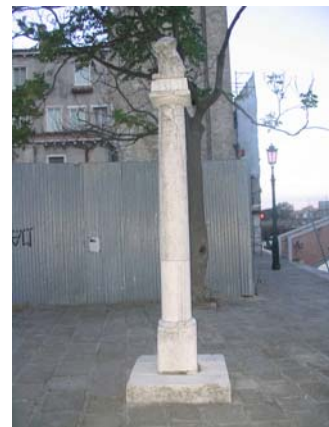
Figure 44: Monument on *San Nicolò dei Mendicoli*

The lion monument, code DD1906, **Figure 44**, will take approximately €5.000 and two weeks to restore. The cracks must be cleaned and consolidated. Further assessment must also be performed to ensure that the monument is stable and that there is no flaking or softening of the material. The scaffolding will cover a meter of the ground surrounding the monument since the monument is 3.34m tall. The scaffolding fee is about €1.500.

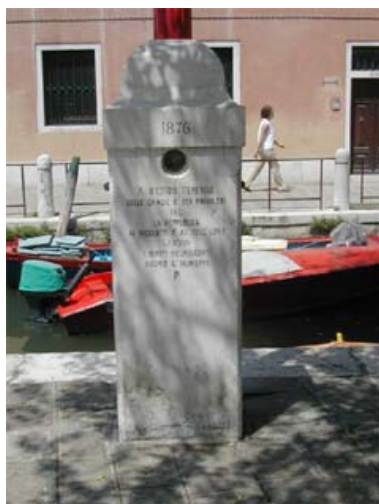
Figure 45: Flagstaff on *San Nicolò dei Mendicoli*

The flagstaff, **Figure 45**, requires cleaning and some consolidation along with a coat of surface protection that is projected to last for five years. Also, the city seal is missing from the flagstaff; a similar one will need to be located and used as a replacement.

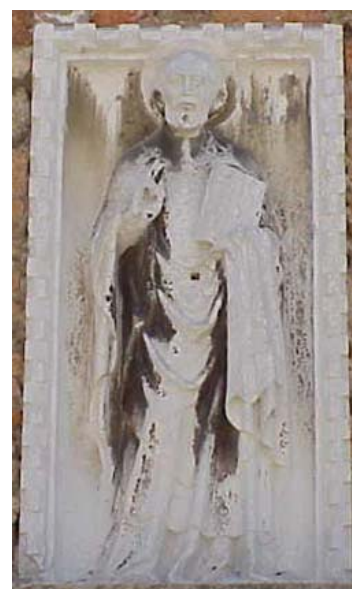
Figure 46: Relief of *San Nicolò*

This relief of San Nicolò, **Figure 46**, *Arte Pubblica* number DD193, was crafted in the 1300s and is thought to still hold some of its original paint. For this reason, aggressive cleansing is not recommended. Instead, only water and a sponge will be used to remove the black grime. If it is
