## **Preservation of Venetian Bell Towers**

An Interdisciplinary Qualifying Project

**Worcester Polytechnic Institute**

Date: July 31, 2004

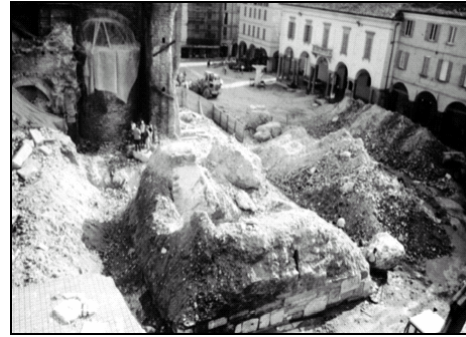
Figure 3- Tower of Pavia<sup>2</sup>

Many are in states of disrepair and have become a nuisance and danger to the surrounding neighborhood. In fact, on March 17, 1989, the Civic Tower of Pavia collapsed. An image of the tower after collapse is shown in Figure 3.<sup>3</sup> This caused a lot of concern within the city of Venice. We will make it a priority to look into the monitoring of bell towers, so the city of Venice can attempt to repair them before such tragedies occur.

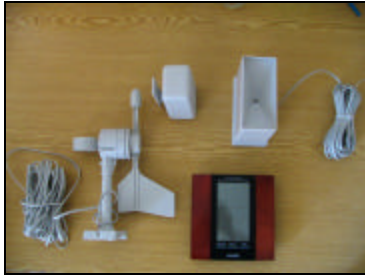
Figure 6- Weather Station

The anemometer is a mechanism designed to measure airflow and air temperature. It measures air speed by passing air over a propeller or some type of blade. A photograph of an entire weather station is shown in Figure 6. The anemometer is the tool on the far left. Next to it is a temperature sensor, and to the right of that is a rain gage.

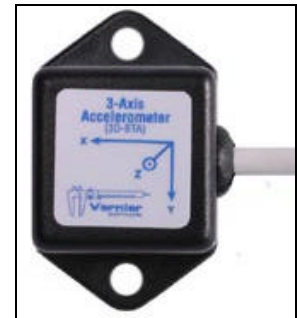
Figure 7- Accelerometer <sup>9</sup>

The accelerometer, shown in Figure 7, is a device that measures acceleration. There are different kinds, but the one we are using is a black square that is affixed to the surface of the object you are measuring. When the surface moves, moving the accelerometer with it, the acceleration of this movement in Gs is calculated. A strong adhesive is necessary to affix the accelerometer is securely. Ours actually report back amounts of voltages through bare wires, and the translation to G's is accomplished on the software end, using the translation rules in the documentation provided by the accelerometer manufacturer. Other accelerometers may use different methods, but all end up calculating acceleration in G's.

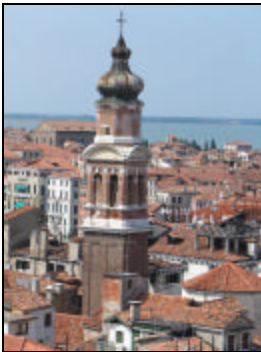
Figure 11- San Bartolomeo

San Bartolomeo is mixed style bell tower. As you can see from the Figure 11, the belfry and steeple are very ornate. If you look closely, you can see some of the exterior siding has chipped away on the drum and exterior of the belfry. The tower itself is in pretty good shape, aside from the chipping of the external covering and mortar on the belfry and spire.

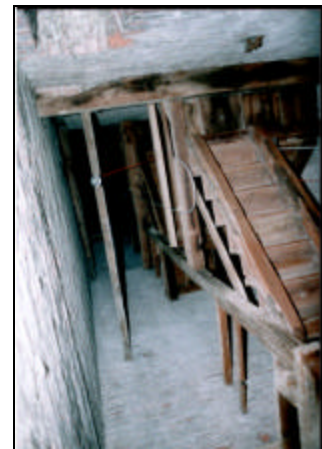
Figure 12- Clean inside

The interior of the tower is in relatively good condition. As you can see in Figure 12, the tower is very clean. This photograph was taken just under two years ago. The reason the tower looks so pristine is because two years ago, the church paid someone to come in and clean the tower spotless. They did a great job, as you can see.

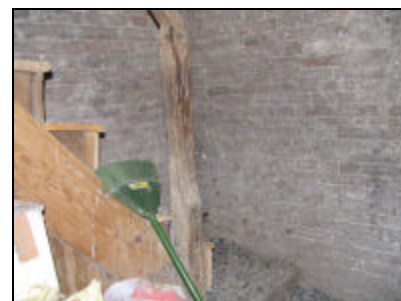
Figure 13- Dirty inside

Yet, at some point in time soon after the cleaning, the sliding door to the belfry was left open, allowing birds to enter the tower. This is bad not only because they covered the entire tower in feces, but because many of them died inside.

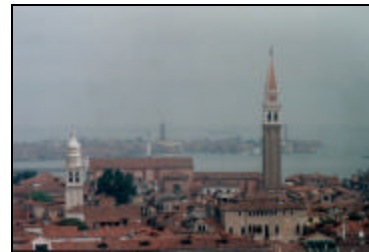
Figure 14- San Francesco de la Vigna

San Francesco de la Vigna is a massive tower with a pyramid shaped attic of red clay shingles and a white stone belfry that pierces the skyline of Venice in northern Castello, as seen in Figure 14. Although the exterior of this tower shows little signs of structural weakness, the inside the tower is in desperate need of repair and structural monitoring; This tower has had minimal restoration since it was built in 1564. The interior of San Francesco de la Vigna shows signs of significant, if not critical, damage to the

bricks, such as cracks and bowing of the walls. The ascent of the tower was made even more perilous due to the minimal lighting in the shaft. There were a few small windows that were covered by mesh and some drop down light bulbs dispersed at the bottom of the shaft.

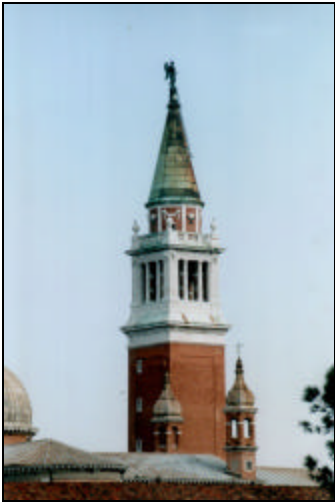
Figure 16- San Giorgio Maggiore

San Giorgio Maggiore, one of the tallest towers in Venice, is located on Giudecca, faces Venice proper and looks straight out onto Saint Mark's Square. The bell tower, shown in Figure 16, is in very good condition. It is extremely clean inside aside from the minor amount of dust buildup. The tower is open to the public. The belfry is only accessible through the use of an elevator to the general public. The belfry is spacious and clean and has a trap door leading down into the shaft, where the public is not allowed. The walls of the tower have had many cycles of restoration, leaving the tower in nearly flawless condition structurally and aesthetically. There is a new banister along the entire length of the ramp on the way up and artificial lighting the

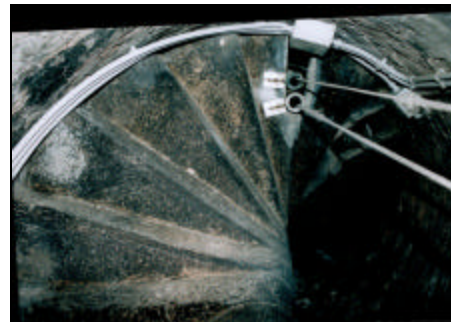
Figure 18- Manual Bell Ringing

used for ringing attached to the bells extending down the tower through carved openings in the stone stairs all the way to the bottom. These large gaps in the stairs make it difficult to ascend the tower.

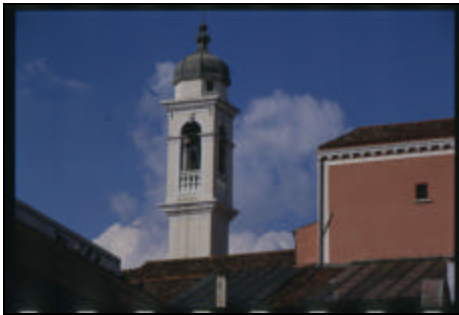
Figure 20- Santa Maria di Nazareth

Shown in Figure 20, Santa Maria di Nazareth, otherwise known as Scalzi, was originally built in 1680. It is located adjacent to the S. Lucia Train Station in the center of Canneregio. A spiral staircase, 175cm in diameter leads up to a caged-in belfry housing two extremely discolored bells. Neither of the bells in this tower have been rung with a hammer, making it safe for us to assume that all the damage done to the tower through the ringing of the bells was done by the rotation of the wheel and the swinging of the bells against the clapper.

The brick walls inside the tower have been covered by a thin layer of concrete for aesthetic purposes. Large cracks in the walls have started to break through the concrete covering, leaving piles of cement all along the stairs. The lower parts of the shaft feature ancient graffiti that prove that the towers shaft has had no major restorations. The condition of the tower drastically worsens the higher you are, and cracks and splits in the wooden stairs become very noticeable.

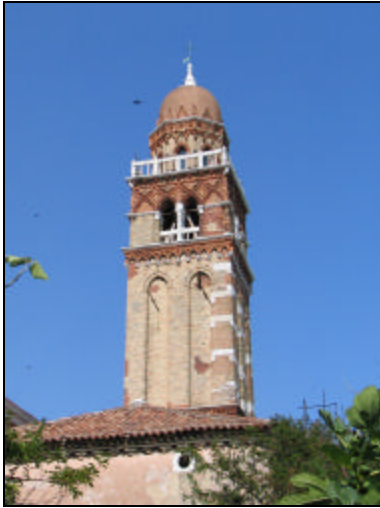
Figure 21- San Michele

Monaci Camaldolesi, more commonly known as San Michele, is a church on the island of Cimitare. It is well-known because it is the bell tower of the only church on the only cemetery in Venice. The bell tower, shown in Figure 21, is actually currently being monitored by an architectural firm from Trieste because of its alarming condition. When the bells were originally hung, the frame was installed incorrectly, which led to a lot of excess strain on the tower's shaft. Figure 22 shows

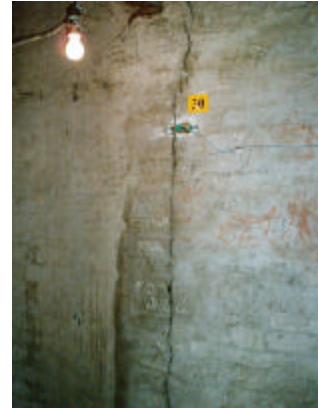
Figure 22- Crack and Strain Gage

one of the strain gages currently in the tower that the civil engineers are using to collect data. Notice the huge crack in the wall of the tower that the strain gage is placed on.

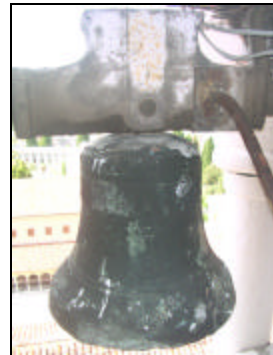
Figure 23- Bell 1

There are four bells total in this tower: three medium sized bells across the center and one small bell on the right side, near the belfry window. The small bell, shown in Figure 23, which we labeled as Bell 1, was in absolutely awful condition. Since it was cast in 1862 it has not been maintained and has decayed to a state that makes it dangerous to the people around the tower. A makeshift safety cable has been rigged around the bell wheel to prevent it from falling off the tower. The most interesting and most important bell in San Michele bell tower is the one that was originally cast in 1777, which for our purposes of referencing and collecting data on, is known as Bell 4. From the photograph in Figure 24, you can see that the bell is extremely chipped along the edges, and quite rusty near the skid marks. More importantly, there is a large crack that is going down the length of the bell. It is pointed out by an arrow.

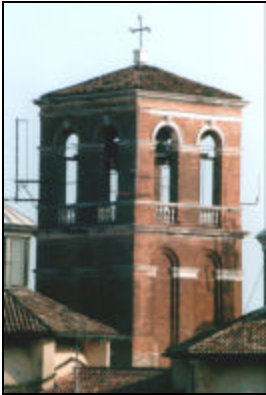
Figure 25- San Salvador

San Salvador is a sturdy brick bell tower located in one of the most central points of Venice from which you can see just about every other bell tower in the city. It is for these reasons that the tower is used as a cellular tower. In Figure 25 it is easy to see the antennas attached to this bell tower. This is due to the fact that the cellular phone company ITIM owns this bell tower and uses it to hold up its antennas, instead of having a cell tower.

The interior of the tower was in such bad condition that one of the wooden stairs towards the top of the tower was completely missing, and the stair below it was rotting through. This made it extremely difficult to ascend the tower. Because it was so unsteady, only one person could be on that landing or staircase at any given time.

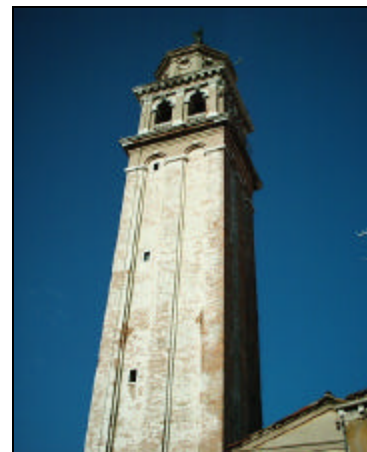
Figure 30- Santa Maria del Carmine

The bell tower at Carmine, shown in Figure 30, is a prime example of a tower in desperate need of restoration. As you can see in Figure 31, the exterior of the tower shows many signs of structural weakness such as cracks, holes, missing bricks, as well as the exterior plaster shell of the tower has completely fallen off. There are many vast cracks that span the entire length of the exterior of the tower. While the exterior of the shaft is in such poor condition the exterior of the belfry is surprisingly in good condition.

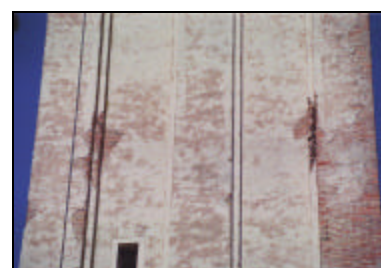
Figure 31- Damaged Exterior

placed there for. The interior of the tower is in better condition than the exterior, but only slightly. Many of the landings have the same cracks, holes and destroyed brick as the exterior. The stairs are made of stone and are very sturdy, but they are littered with pieces of broken brick. Many of the wooden ties inside the bell tower have lost their usefulness due to the rotting of the wood. Assent up the stairs is made even more difficult and dangerous by the minimal artificial lighting inside the tower. The interior of the belfry is in fair shape, although the floor has not been cleaned since the installation of bird netting.

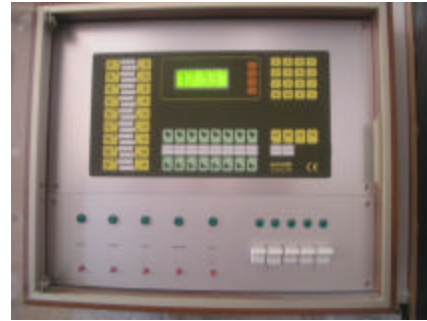
Figure 32- Automatic Ringing Mechanism

The bells and the bell frame are both in good condition and are the only parts of the bell tower that have had been maintained. The bell frame is wood and in above average condition with no bends, warps or cracks. Recently the bells have been retrofitted with a modern ringing mechanism. The original automatic ringing mechanism can be seen on a landing below the belfry in Figure 32. The bottom floor of the tower contains a unique inscription at the stairs of the tower. It is shown in Figure 33. Through our visual analysis we have concluded that this tower is in desperate need of renovation and monitoring.

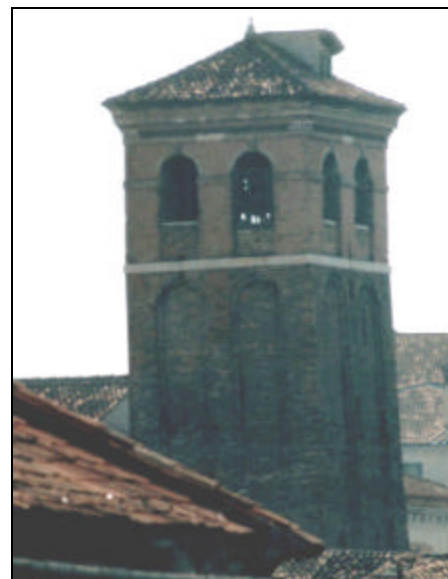
Figure 34- San Stae

When compared to all of the towers our group has visually assessed, the tower of San Stae represents the average condition of the Venetian bell towers. As you can see in Figure 34, the exterior of the tower shows no significant signs of structural deficiencies. Through our analysis of the bricks we have concluded that this tower has gone through two to three restoration periods. The layers of new brick are located at the corners of the towers base indicating the potential for the insertion of reinforcement beams into the tower's walls. The exterior walls show few signs of deterioration, with minute cracks throughout the tower walls being the only noticeable damage. Although

these cracks might not seem very significant, small cracks often are the cause of structural instability. This can only be determined through instrumental monitoring of the ground around the tower and the tower walls. The inside of the tower provides mixed messages about the towers condition. Through analysis of the condition of each wall by landing we are able to conclude that three of the walls are in good condition and the back wall is in drastic need of monitoring. The back wall of the tower from the inside is littered with cracks of various severities. This could have been caused by many factors, such as the force of another wall pinching the back wall, or by the towers foundation shifting under that side of the tower.

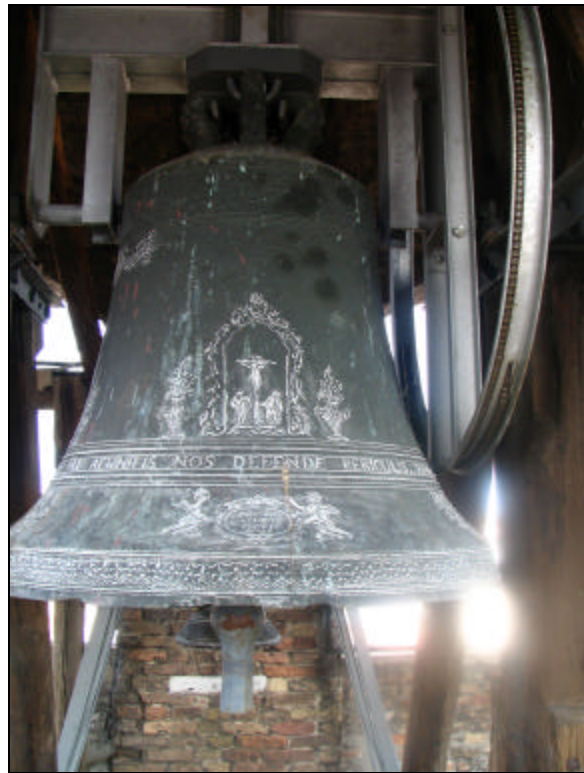
Figure 35- Pristine bell

The most noticeable renovation that has been completed on the tower was performed on the belfry and the bells. The belfry was replaced within the past two or three years and is in pristine condition. The clappers of the bells are also in perfect order with no rust or rot present anywhere on the body of the clapper or the belt. Some routine maintenance has also been performed on the bells. The bells have been cleaned and detailed at the top where they were hung from the frame. The only damage that has occurred to the bells as a result of the re-hanging is that the second bell has a small chip taken out of the lip to make room for the new wheel. This may be significant because that small chip may affect the pitch of the bell. A photograph of one of the bells showing the cleanliness of the bell, the clapper and the wheel is shown in Figure 35. Although this tower has some minor structural issues, the tower is close to the canal and there for may be used potentially as a surveillance point or a tour destination.

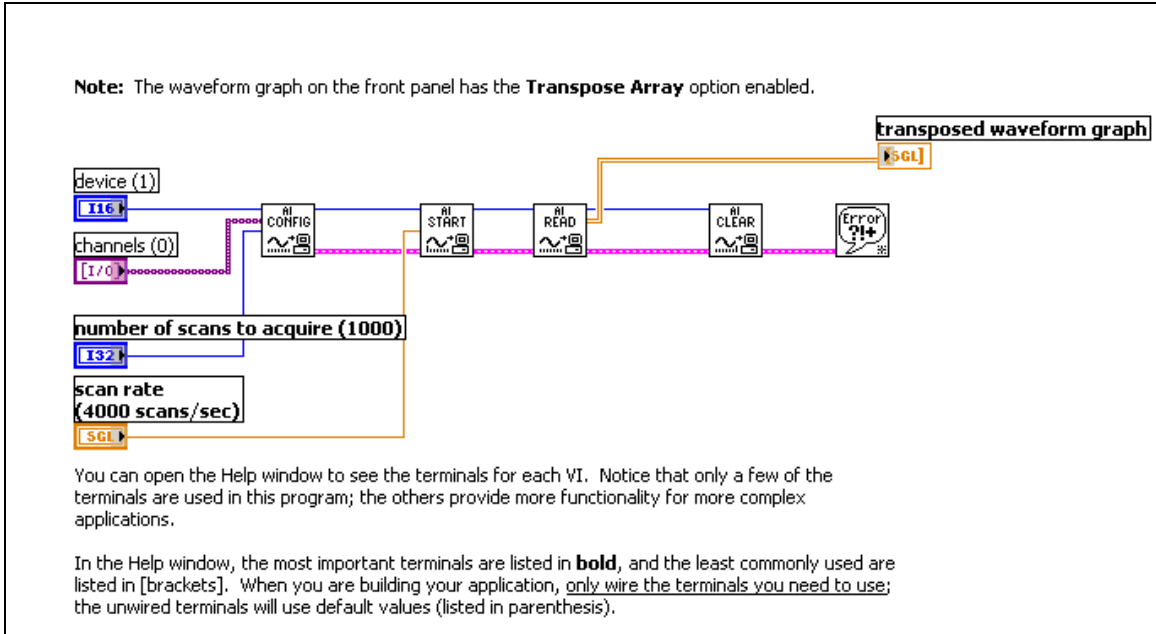
Figure 42- Backend of GetReadings.vi

The acquisition of data is managed by Get Readings.vi, a subVI used in Bell Towers Recording. The back end is shown in Figure 42.

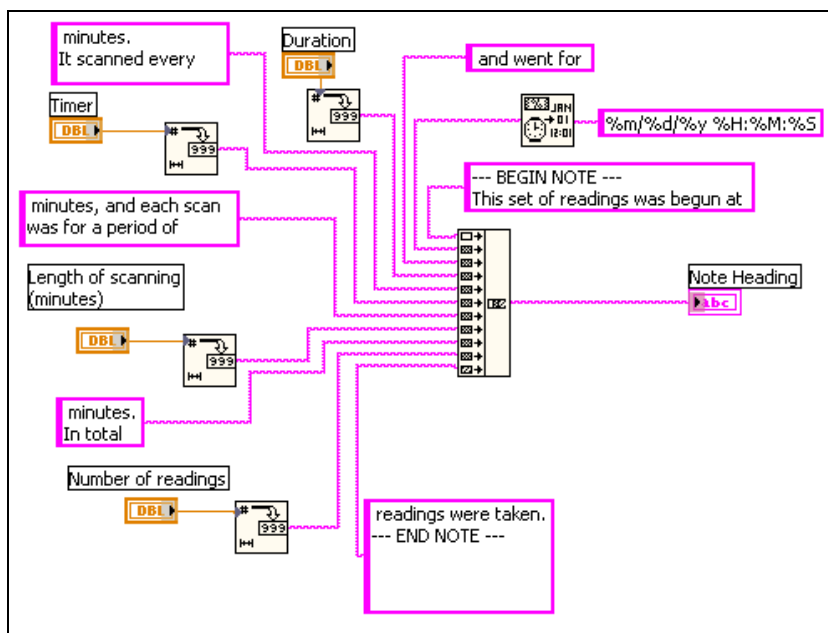
Figure 44- Backend of MakeRecordingNote

Make Recording Note is run only once while the VI runs, right at the beginning. It writes a note to the beginning of the file which describes the parameters selected when the VI was run, as well as the date and time the instrument reading session began. Make Recording Note's backend is shown in Figure 44.

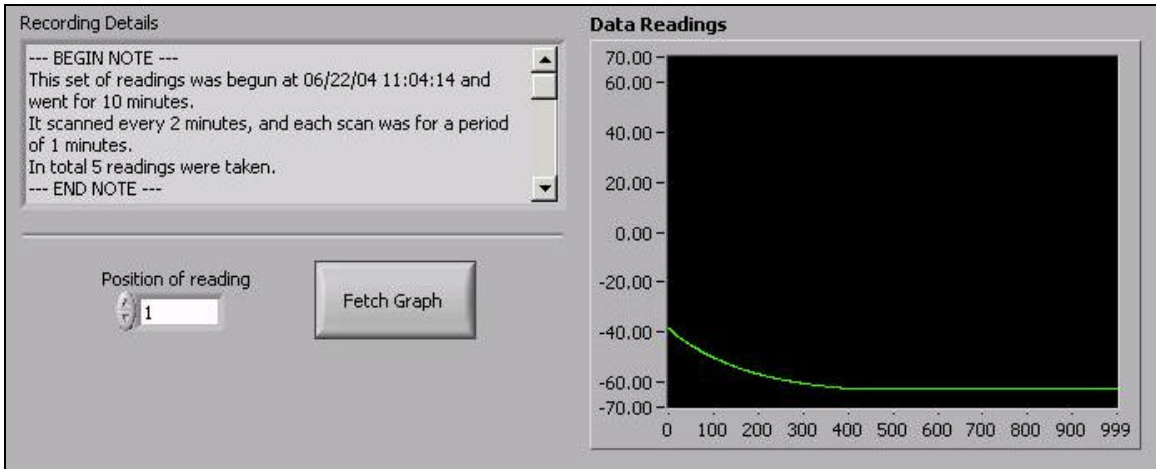
Figure 46- User Interface of BellTowersViewer.vi

The other main VI we built is Bell Towers Viewer.vi. This is not used during the recording of data, but rather a helpful tool for viewing the data we have recorded. Figure 46 is a picture of the interface and Figure 47 back end.
