Public Art Preservation in Venice: Non-public Wellheads and Fountains

An Interdisciplinary Qualifying Project
Submitted to the faculty of
WORCESTER POLYTECHNIC INSTITUTE
in partial fulfillment of the requirements for the
Degree of Bachelor of Science

Date: July 29, 2004
<http://users.wpi.edu/~gratner>
Wells-e04@wpi.edu

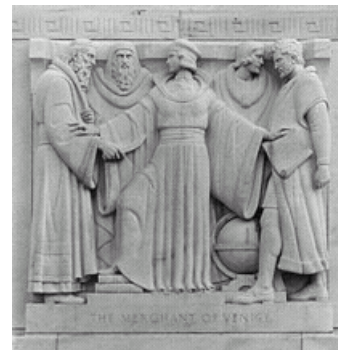
Figure 6: Relief depicting The Merchant of Venice¹⁶

Reliefs are sculptures that are made on walls and are raised up from the surface. There are two different types of reliefs, high and low. They are categorized by the amount of the figure that protrudes from the surface. A high relief sculpture has half or more

of its depth protruding from the surface, while low relief sculptures are those with less than one half protruding. There are 386 relief sculptures found on the walls of Venetian building.¹⁷ An example of a relief is shown in Figure 6.

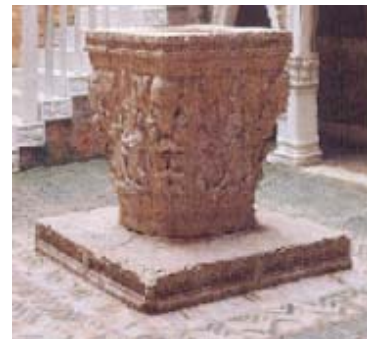
Figure 7: Wellhead in Venice

The wells of Venice were not constructed like normal “artesian” wells, simply because the surface of the island was formed from swampland, which were filled with salt water. Due to this problem, the Venetian people devised a system of cisterns that would collect rainwater, filter it, and retain it in a clay basin, which citizen could then access. The wellhead was the part of the well that was above ground. Wellheads can be found throughout the city in most *campes* (see Figure 7)²¹. This system provided Venice’s fresh water for hundreds years until the implementation of the aqueduct from the mainland in 1882-84.²² There are 217 public wellheads in Venice today²³.

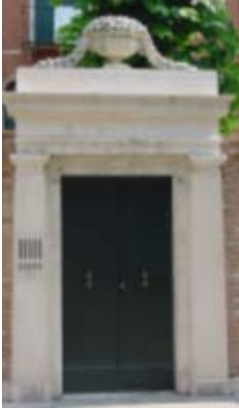
Figure 8: Portali²⁴

Portali are doorways that include structural artistic elements. *Portali* were created as a way to dignify an entrance to a building or courtyard. There are 552 *portali* located around the doors of Venice²⁵. One is shown in Figure 8.

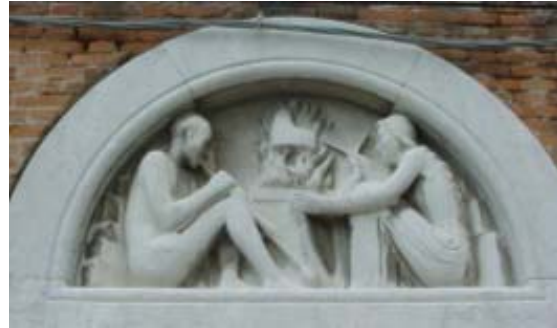
Figure 9: Lunette²⁶

*Lunette*²⁷ are a subset of *portali*. *Lunette* are artistic sculptures located in an arch doorways on the outside. The main

purpose of *lunette* are to create an ornate entranceway and to serve as status symbol. There are 71 *lunette* in Venice²⁸. One is shown in Figure 9 .

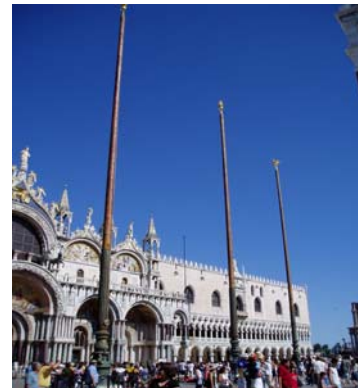
Figure 10: Flagstaff and Pedestal

Flagstaff pedestals are often located in the *campi* around Venice. They support the flagpoles, which served as another method of identifying a certain area with a family, *scuole*, or other organization. The body of the flagstaff generally contains some sort of carved design or inscription. There are 57 pedestals throughout Venice, although only 35 of them contain flagstaffs, one of such is shown in Figure 10.

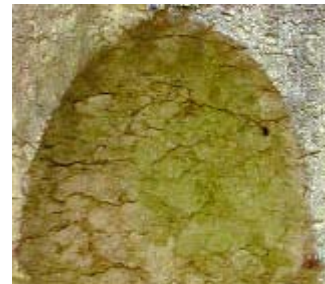
Figure 12: Biological damage³²

Biological considerations such as fungi, algae, lichens, and bacteria all can lead to destruction of the wells simply by the natural decay of the stone, due to the chemical agents and biological acids they can produce, as seen in Figure 12.

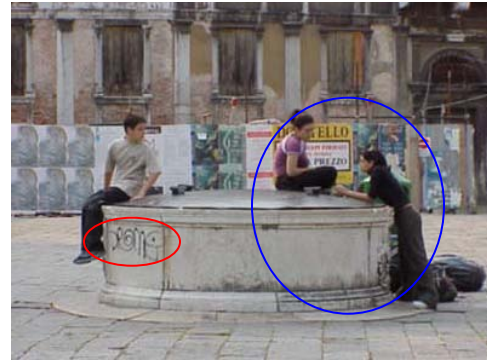
Figure 13: Unintentional damage and Vandalism³⁵

Manmade damage includes the defacing of the structures with graffiti and unintentional abuse (see Figure 13). Examples of such abuse are: people accidentally breaking pieces off the stone as they sit on them; placing an additional weight load or leaning on art, which are pressure they were not designed to withstand. Another example of this was in recent news; someone was caught attacking and defacing multiple pieces of public art in Venice. He was consequently arrested and put in jail³⁶.

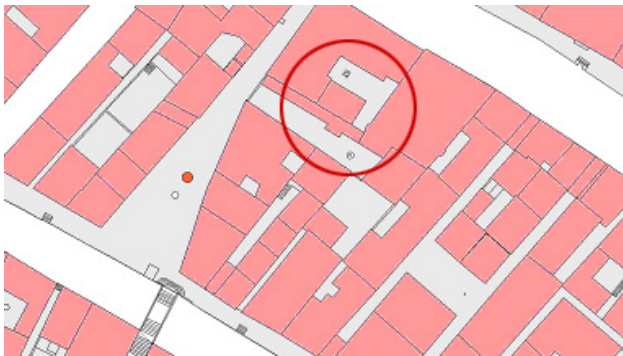
Figure 14: Documented well verses possible well.

To determine the actual locations of non-public wells we used a preexisting map of the city's architecture. First, we established all the potential locations by tracking down small circles in enclosed areas. As shown in the map (see Figure 14) the red circle indicate two possible locations for non-public wells and the orange dot represents a public well

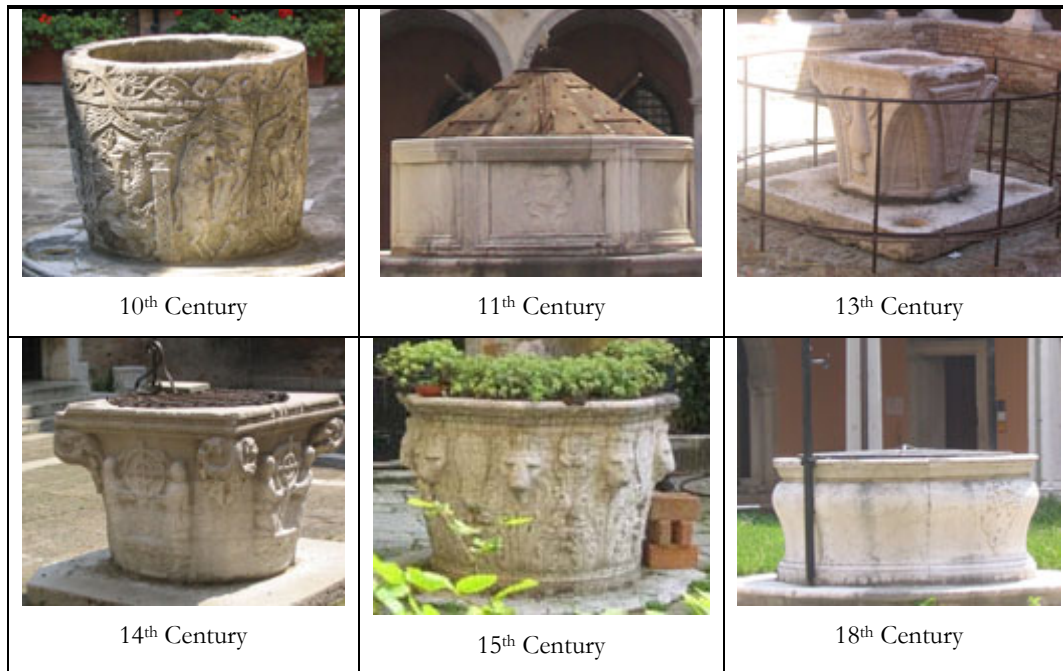
Figure 15: Wellheads Styles by Period

Venetian wellheads were created in several unique styles typical to the century in which they were created. By knowing the general styles and shapes of each century it was possible to accurately date majority of the wellheads. The styles are broken down in the following categories: 8th-9th century, 10th century, 13th century, 14th century, 15th century, 18th century, and post 18th century. This data is important for the preservation effort since some types of wellheads are nearly extinct and thus require more immediate attention than others. The example of each style can be seen in Figure 15.

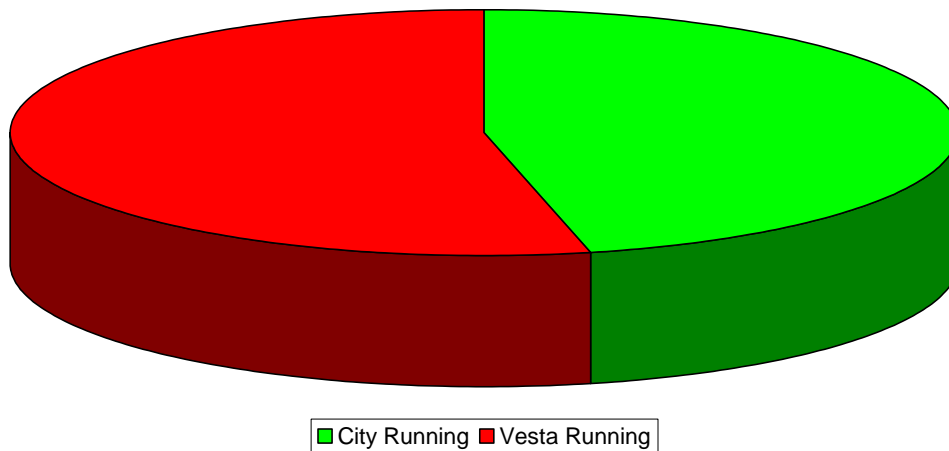
Figure 25: Percentage of Fountains Running by Owner

The next graph (see Figure 25) compares the amount of running fountains to each owner to show which has more operational fountains.

From this graphs it is possible to determine which owner is providing more water to the city. Out of the running fountains, VESTA has a greater percentage than the city, with VESTA averaging at about 71 percent and the city with 61 percent.

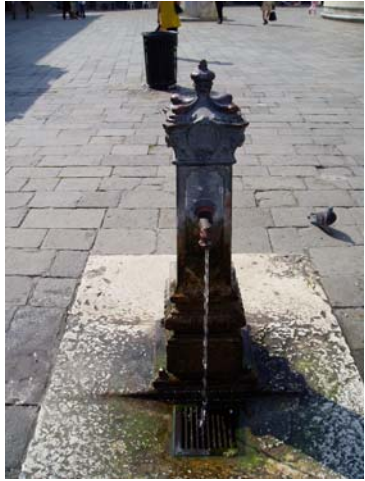
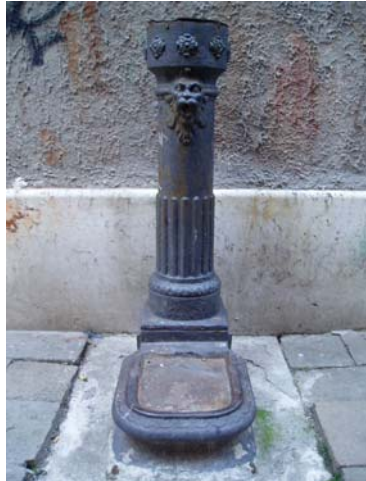
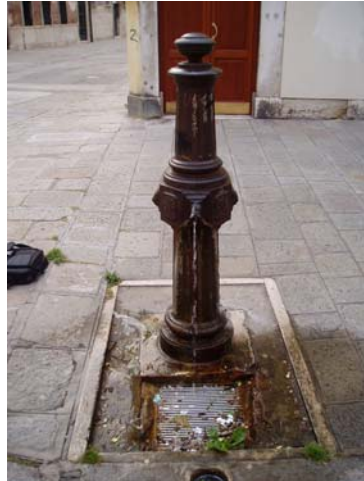
<p>Delfini Type A</p>	<p>Puglia Type B</p>	<p>Alto Type C</p>

The following are the main types of fountains that exist in Venice.
