CAPE TOWN WATER AND SANITATION DESIGN

A Major Qualifying Project Proposal

WORCESTER POLYTECHNIC INSTITUTE

Date: April 23, 2009

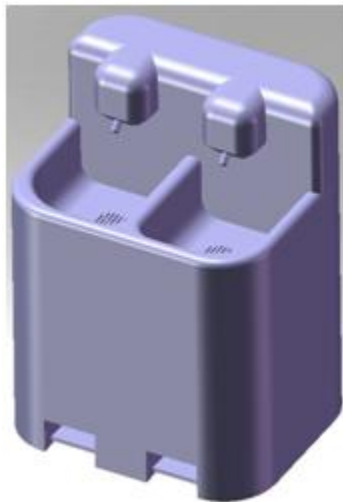
Figure 15: Proposed Hand Washing Station (Granfone *et al.*, 2008)

Public sinks would be part of the facility as well. Granfone *et al.* (2008) recommended the sinks use water primarily from rainwater collection tanks. Although the rainwater collection tanks are unlikely to supply sufficient water for full-time use, the strategy conserves water and reduces the demand on the municipal water system. Public sinks should encourage hand washing, especially if soap is provided. This would hopefully decrease the transmission of disease around the facility. Walking paths would lead people past the sinks as they exit the facility to further encourage hand washing. A sample hand washing station is shown in Figure 15.

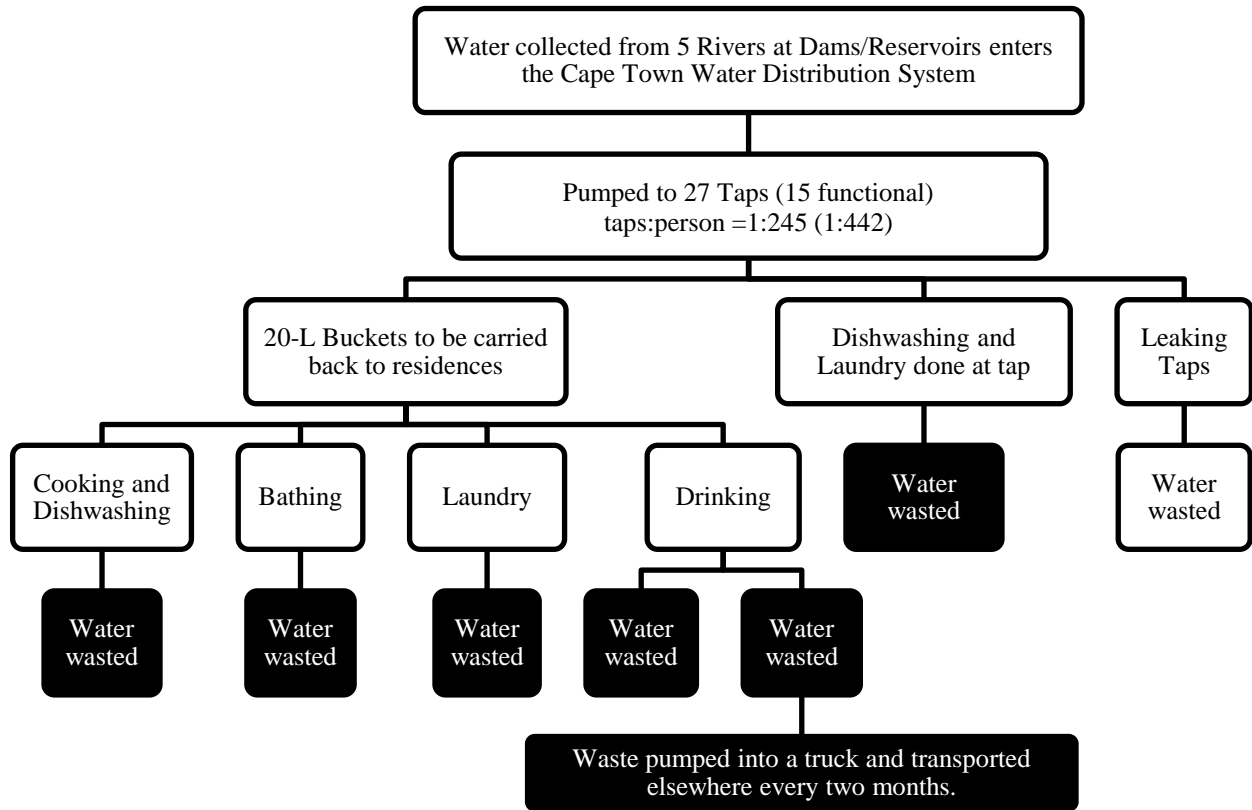
Figure 18: Water Flow through the Community

Figure 18 displays the flow of water from the city distribution system to the home of a Monwabisi Park resident. In this figure, the black boxes represent water that has been used and contaminated. As shown by Figure 18, almost all of the water used by Monwabisi Park residents is wasted after it is used. This dirty water is disposed of in the streets and yards of residents, contributing to the high amounts of standing water that pose potential health risks. Current water use practices provide no means for used water to either be treated or reused.

By comparing Figure 23 and Figure 24 to Figure 18 in Section 3.6, it can be concluded that the facility would greatly decrease the amount of water that is wasted within the community. When water is wasted, it contributes to standing water, thus exposing the residents to public health risks. When water is treated in the facility, it is recycled and reused to water the garden. Additionally, any water that infiltrates through the garden or additional leach field would be naturally treated and thus would not be contaminating groundwater. Most importantly, water would be delivered to the community safely and reliably.

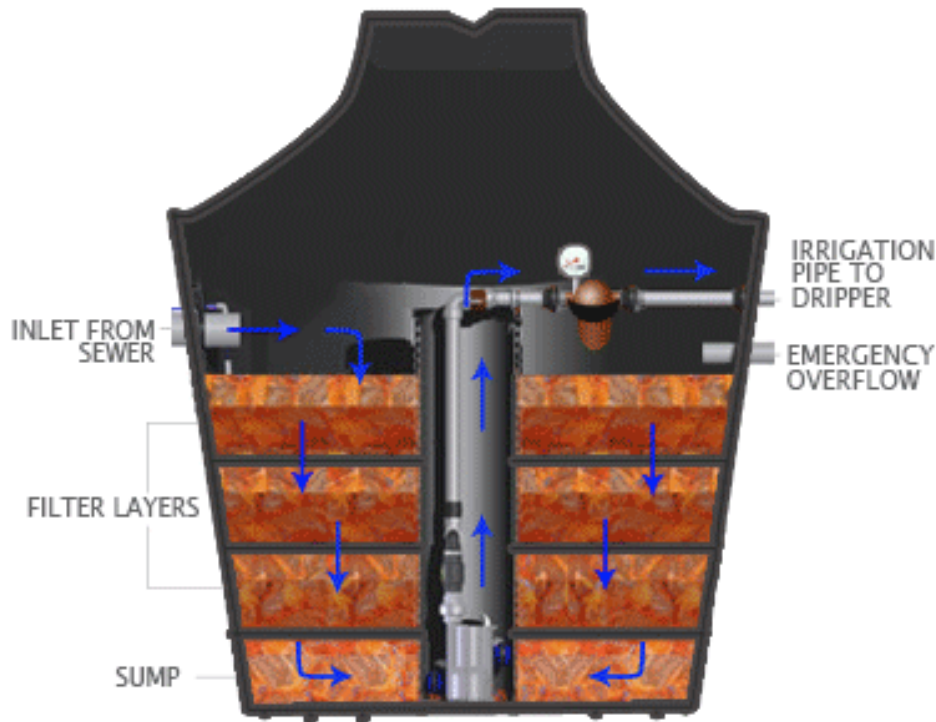
Figure 21: The Biolytix Design (Biolytix, 2009)

The filters that comprise the Biolytix system are contained in a 3000-liter polymer tank. The system needs 40 watts/day of electricity to support the industrial strength pump and air pump to bring the water to the irrigation system. Figure 21 shows the design of the tank (Biolytix, 2009). Each tank can treat 2200 liters of wastewater per day and results in a “3-4 log reduction in thermotolerant coliforms” (Biolytix, 2009).
