Investigation of Fire Impact on Structural Steel through Case Studies

A Thesis Report

WORCESTER POLYTECHNIC INSTITUTE

Date: May 4, 2006

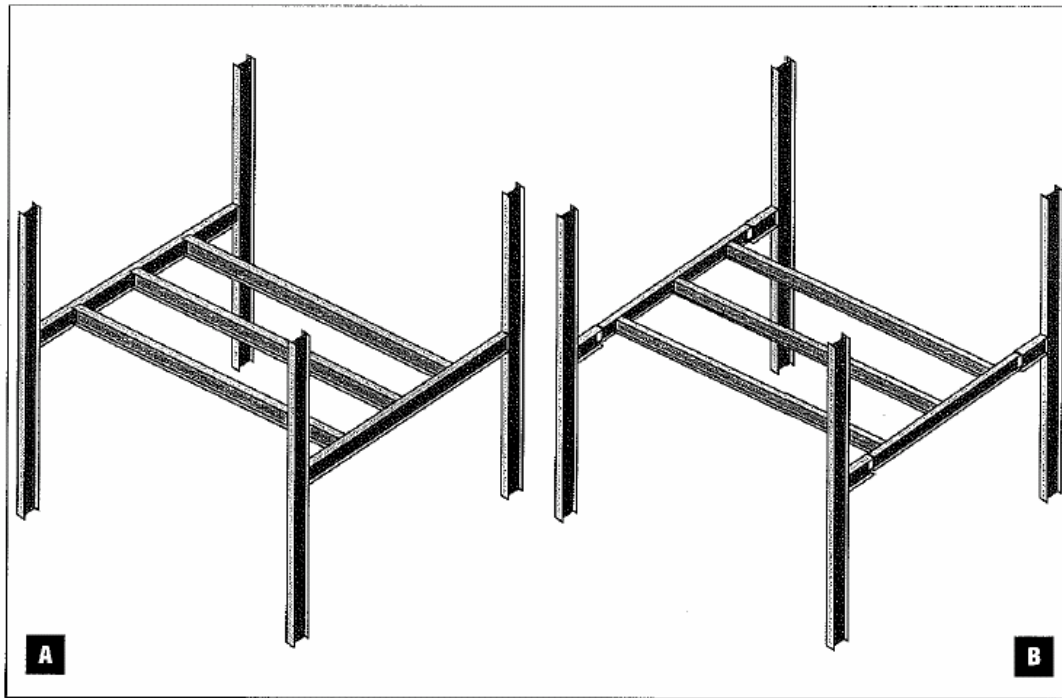
Figure 8 - Interior Bay Framing of WTC 5 (Barnett, 2002)

World Trade Center 5 was a nine-story office building that was completed around 1970. Fire in this building broke out due to debris that impacted the building from the collapse of the World Trade Center towers on September 11, 2001. The subsequent fires caused shear connectors of the column tree assemblies to fail initiating collapse from the eighth floor through the fifth floor. The roof and ninth floor (which contained no column trees) as well as the fourth floor and floors below experienced no collapse. The column tree assemblies and conventional framing systems can be seen in Figures 7 and 8 below.
