**Structural and Nonstructural Building System Performance During
Earthquake and Post-Earthquake Fire**

Fire Test Program – Executive Summary

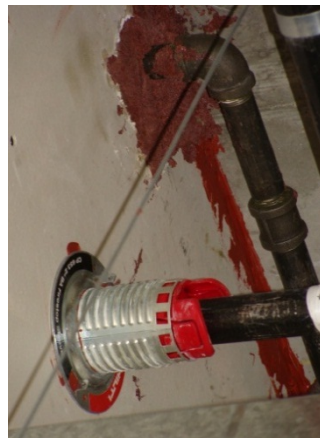
Fire Stop Components

All dynamic and truly static firestop systems installed on Floor 3 performed generally well during the motion tests and to the fire tests except, in earthquake conditions, some joints that would be static in normal operation were not static anymore and joint seals applied on such joints became separated by the ground motion. The potential fire performance concern is loss of compartment integrity and spread of fire and smoke.

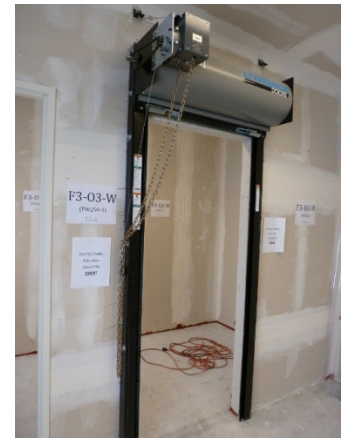
Fire Door

The roll-down steel fire door was intentionally not subjected to significant in-plane drifts during the motion tests and resisted shaking perpendicular to the plane of the door effectively (no damage, see Chen et al., 2013 and Pantoli et al., 2013 for more details) and activated as expected during fire tests.
